CAFO FACILITY INSPECTION REPORT

<u>8335678001</u> WDID NUMBER	<u>Andy Dyt</u> OWNER NAME	<u>Dyt Heifers</u> FACILITY NAME
<u>CAG018001</u> NPDES NUMBER	<u>Ex. 6 Personal Privacy (PP)</u>	
<u>R8-2007-0001</u> RWQCB ORDER NO.	<u>Corona, CA 92880</u> OWNER CITY AND STATE	<u>Corona, CA 92880</u> FACILITY CITY AND STATE
<u>04/10/2013</u> SCHEDULED INSPECTION DATE	<u>Andy Dyt</u> OWNER CONTACT	<u>Andy Dyt</u> FACILITY CONTACT
<u>04/10/2013</u> ACTUAL INSPECTION DATE	<u>Ex. 6 Personal Privacy (PP)</u>	
<u>Santa Ana River</u> RECEIVING WATER	<u>Ex. 6 Personal Privacy (PP)</u>	
	<u>Ex. 6 Personal Privacy (PP)</u>

REPORT PREPARED BY: Anthony D'Angelo (PG Environmental, LLC) ON 04/22/2013

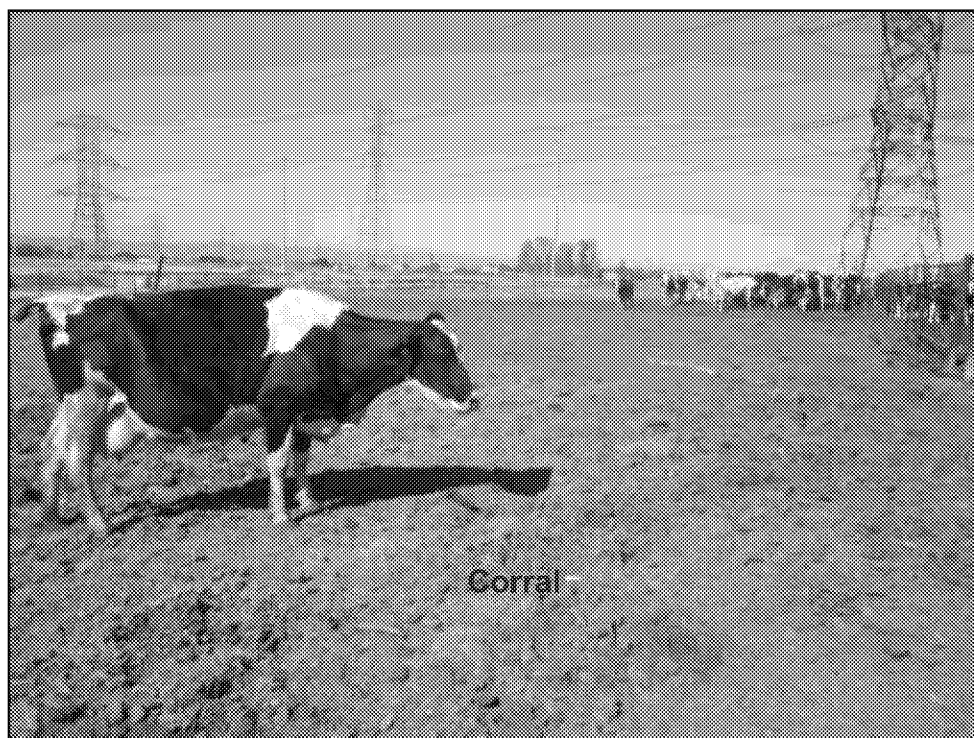
1. The inspector observed, during the inspection, adequate housekeeping and pollution prevention practices at the Facility. Corrals and feed lanes appeared to be adequately maintained at the time of the Facility inspection (refer to Photos 3 and 4).

Photograph 3. View facing southwest of the southern corrals. Corrals at the Facility appeared well maintained and did not contain significant accumulated manure.

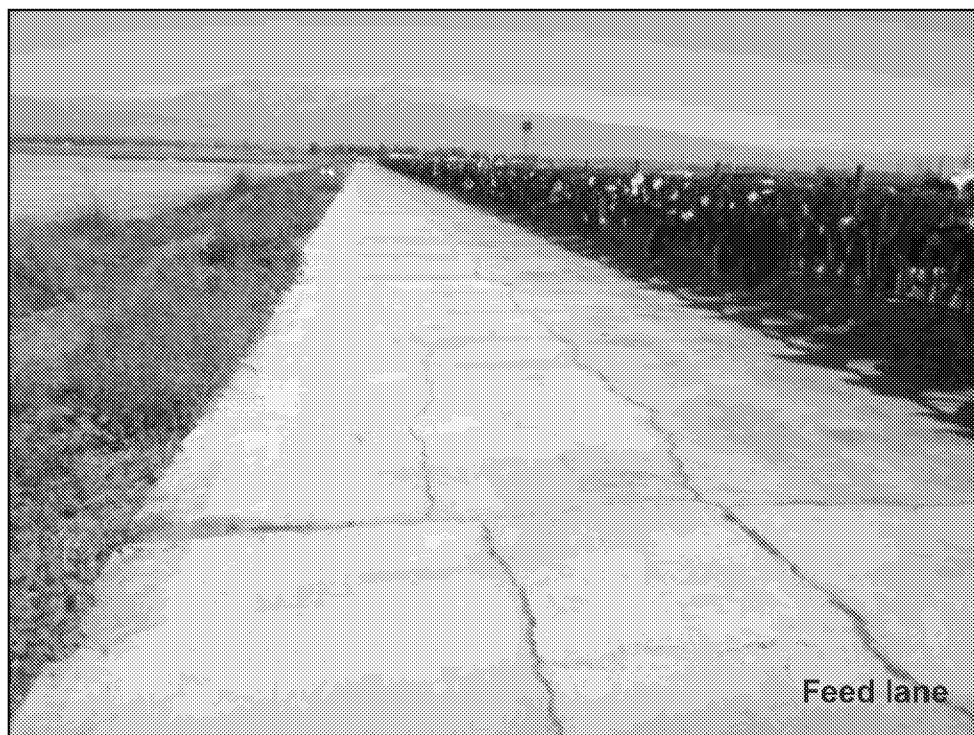
Photograph 4. View facing north of the western feed lane. Feed lanes appeared well maintained at the Facility.

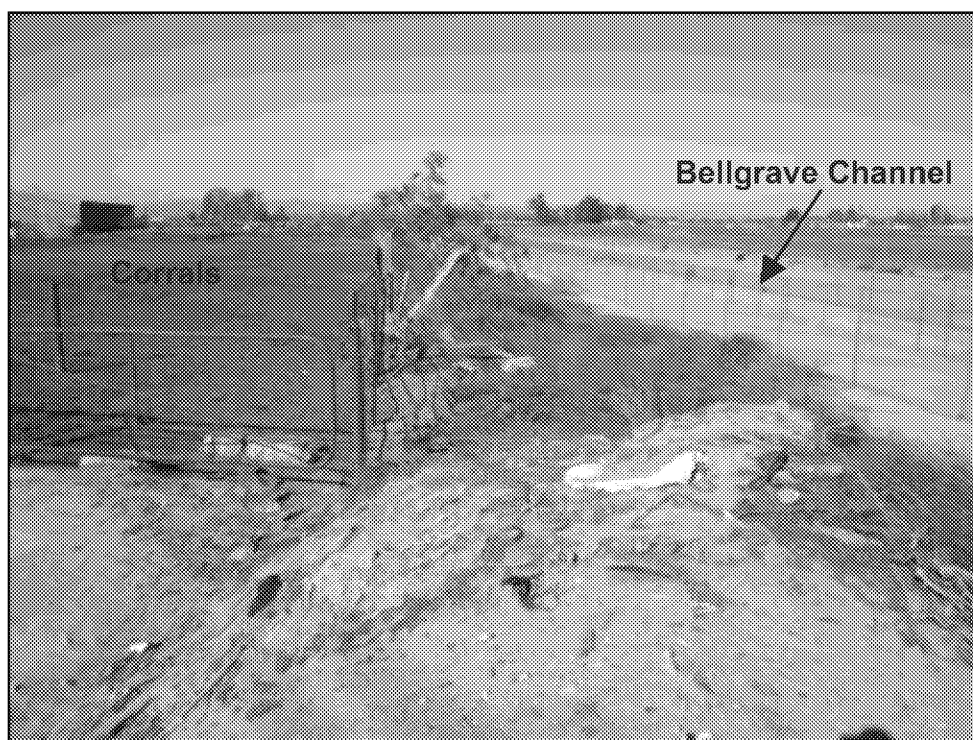
Photograph 5. View facing southwest of Bellgrave Channel that runs along the northern perimeter of the Facility.

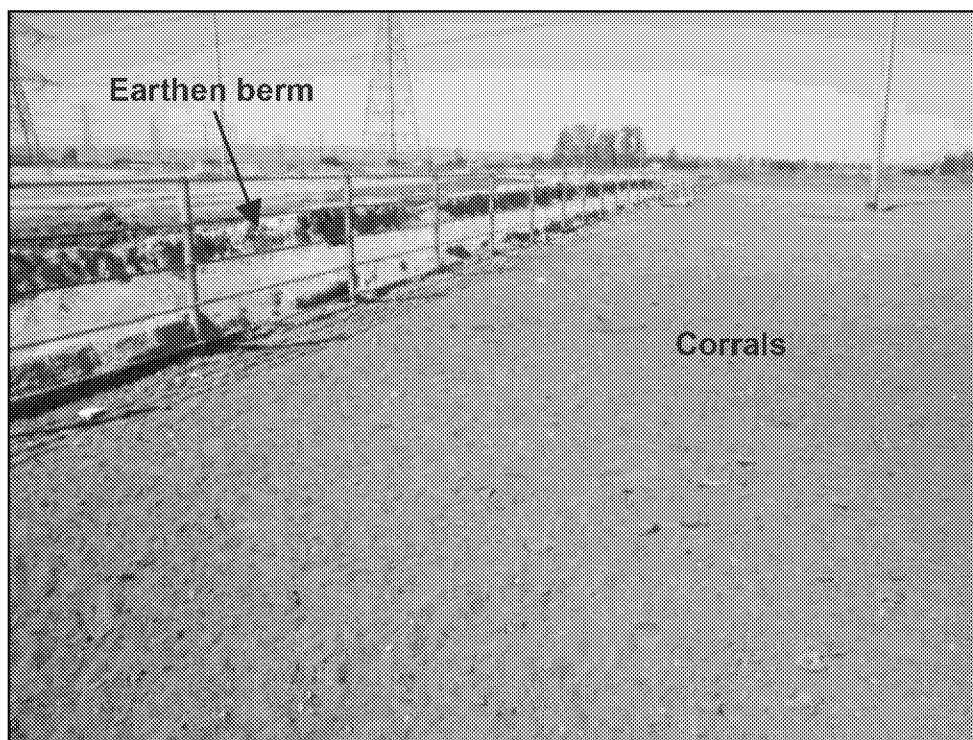
2. The EWMP was not reflective of current Facility conditions at the Facility, as required by Provision VII.C.3.b of the Permit (refer to Photos 6 through 14).

2. The EWMP was not reflective of current Facility conditions or fully implemented onsite at the Facility as required by the Permit. The 'Stormwater Run-off' section of the EWMP states "stormwater runoff from the corrals is directed by gravity flow toward the lower elevated ponds on the southeast portion of the property." Mr. Fernecio stated that an earthen berm had been previously constructed along the southern perimeter of the Dyt Heifer's corrals to contain all storm water runoff within the corrals to prevent surface runoff from entering the Facility containment ponds (refer to Photos 6 through 14). It should be noted that Mr. Geoffrey Vanden Heuvel (Owner, J & D Star Dairy No. 2) stated that he is responsible for the maintenance of the Facility containment structures, and that only process wastewater from his operations is collected into the containment structures. Due to the grade of the Facility corrals, it appeared to the inspector that storm water runoff from the Dyt Heifers corrals would accumulate in the southwest corner of the central southern corral, immediately north of pond No. 1 (refer to Photos 8, 9, and 10). Therefore, the Discharger was operating the Facility without a containment structure. It should be noted that two (2) gaps (i.e., gates) were observed in the southern earthen berm (refer to Photos 11 through 14). As a result, the Discharger was not fully implementing the approved EWMP, nor was the EWMP reflective of current Facility conditions at the time of the inspection. Provision VII.C.3.b of the Permit states that "the discharger shall develop and fully implement an Engineered Waste Management Plan (EWMP) acceptable to the Executive Officer." The Discharger shall design, construct, and maintain containment structures and fully implement the EWMP as required by Provision VII.C.3.b of the Permit.

Photograph 6. View facing southwest of the earthen berm constructed along the southern perimeter of the southern corrals. Note this berm was constructed to contain all surface runoff within the corrals and is not identified in the approved EWMP.

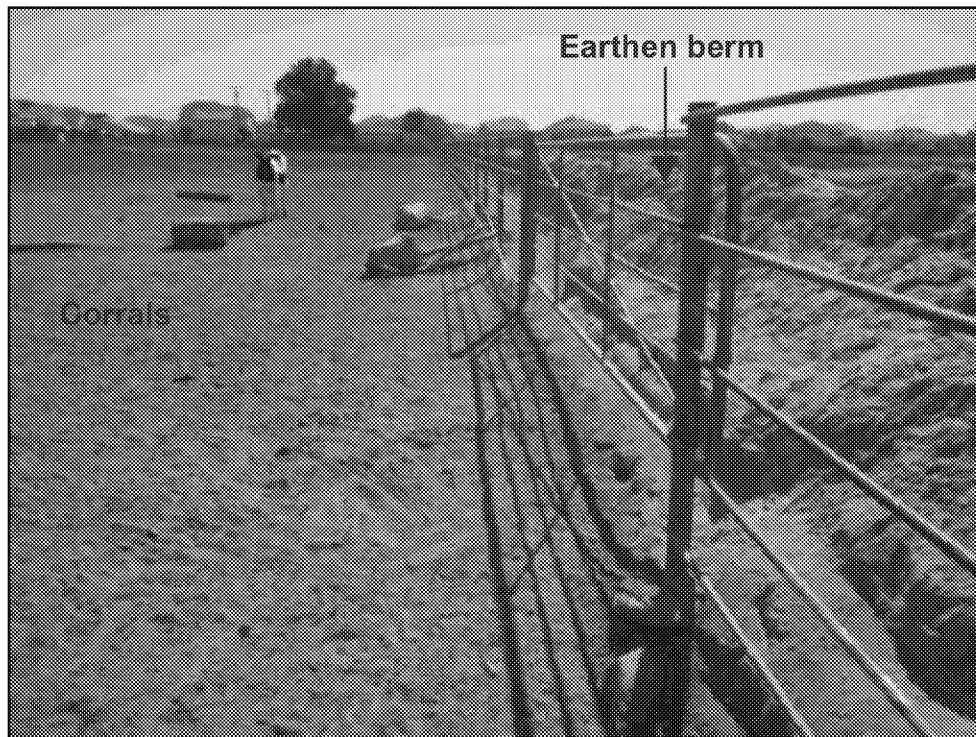
Photograph 7. Additional view facing east of the earthen berm constructed along the southern perimeter of the southern corrals, shown in Photograph 6. Note that this berm was not identified in the approved EWMP.

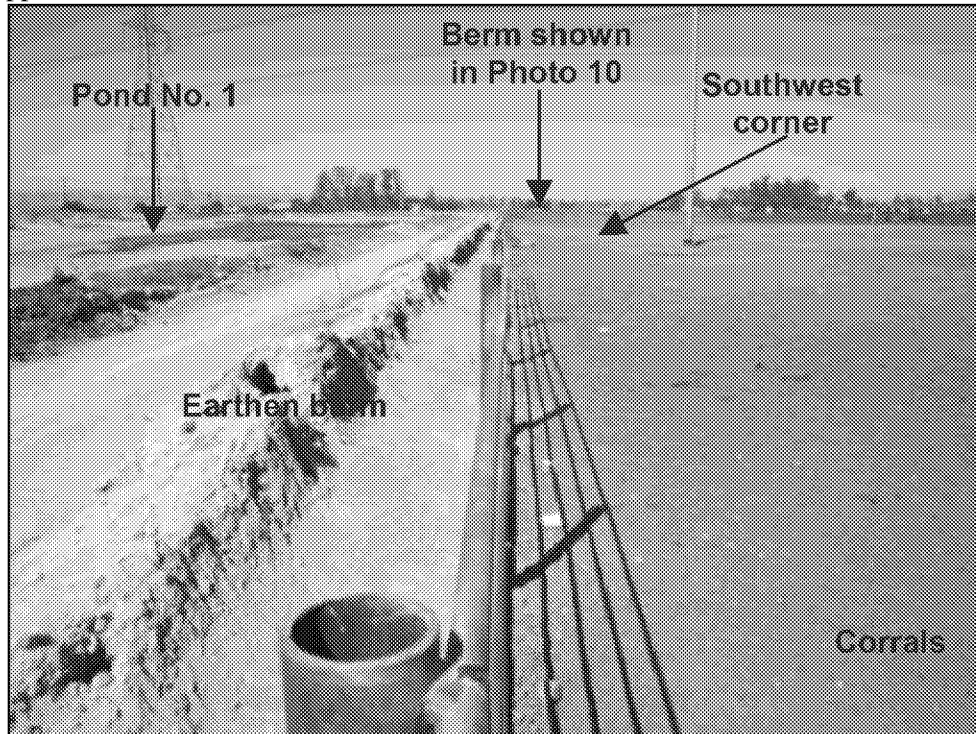
Photograph 8. Additional view facing west of the earthen berm constructed along the southern perimeter of the southern corrals, shown in Photographs 6 and 7. Note it appeared to the inspector that storm water runoff from the Dyt Heifers corrals would accumulate in the southwest corner of the central southern corral.

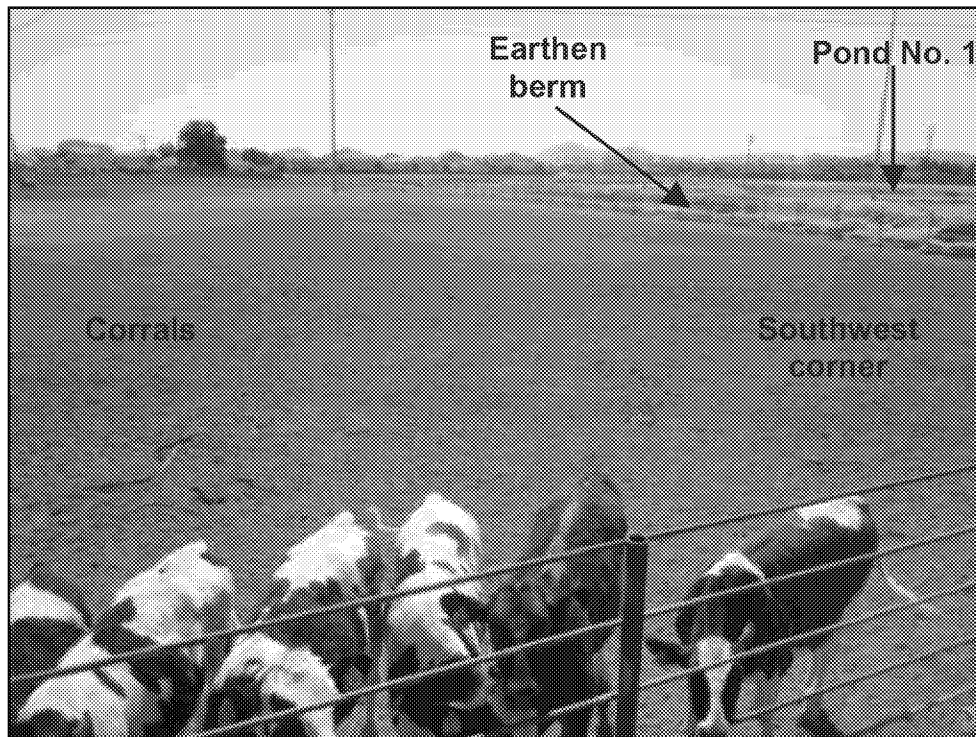
Photograph 9. View facing southeast of the earthen berm constructed along the southern perimeter of the southern corrals, shown in Photographs 6, 7, and 8. Note it appeared to the inspector that storm water runoff from the Dyt Heifers corrals would accumulate in the southwest corner of the central southern corral.

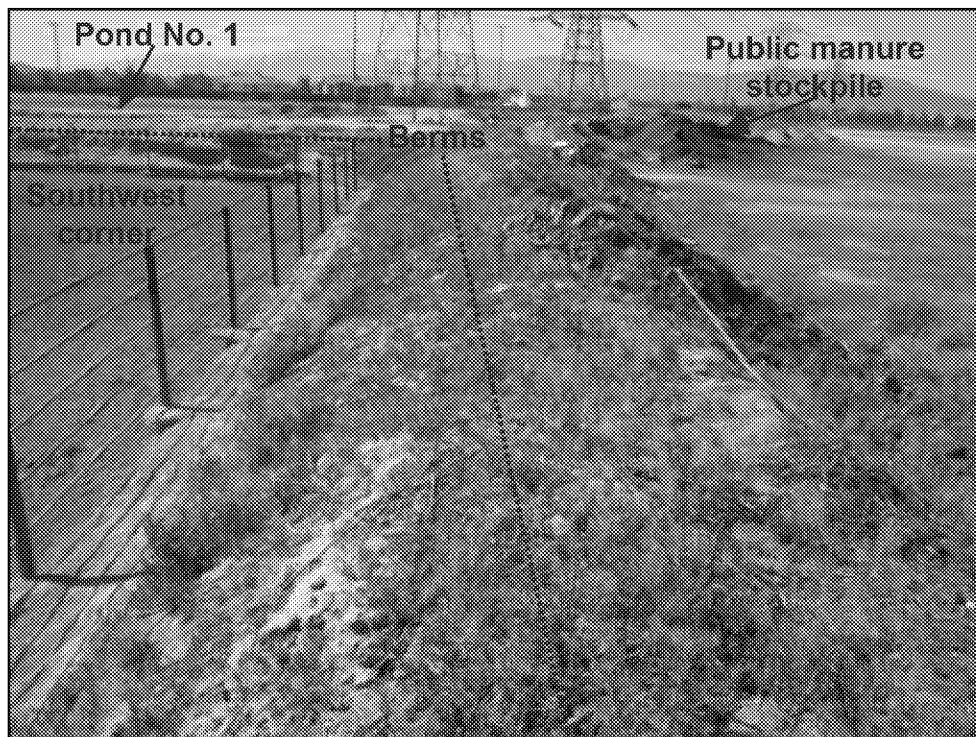
Photograph 10. View facing south of the earthen berm around the southwest corner of the central southern corral. Note it appeared to the inspector that storm water runoff from the Dyt Heifers corrals would accumulate in the southwest corner of the central southern corral.

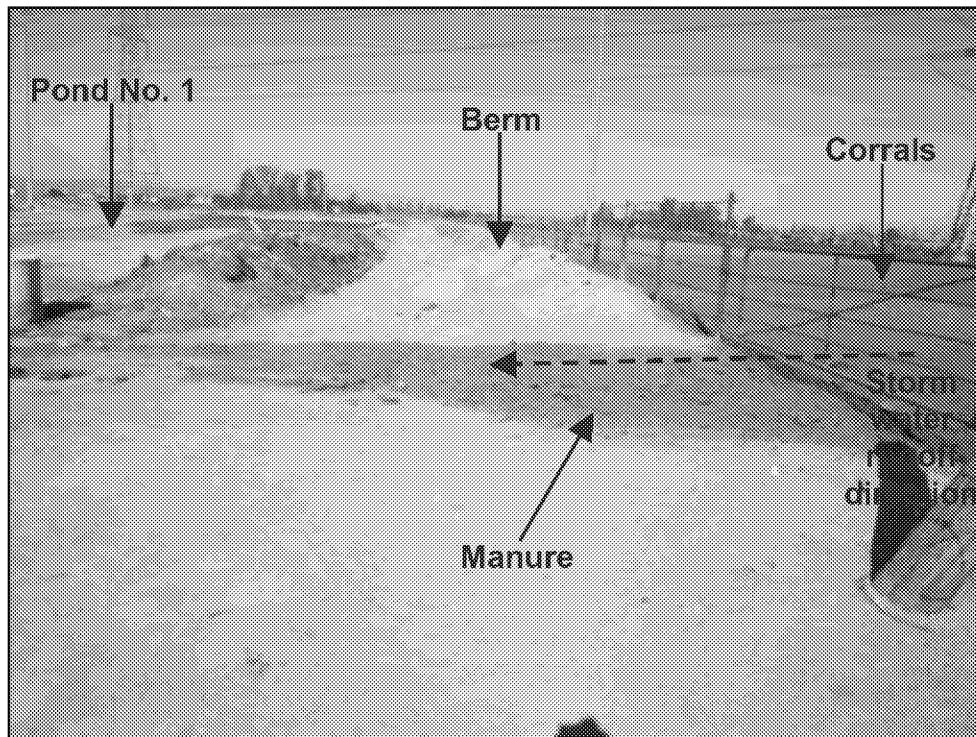
Photograph 11. View facing west of a potential location for storm water runoff to be released out of the southern corrals into pond No. 1. Note the primary Facility representative stated that the earthen berms, shown in Photographs 6 through 10, contain all corral storm water runoff.

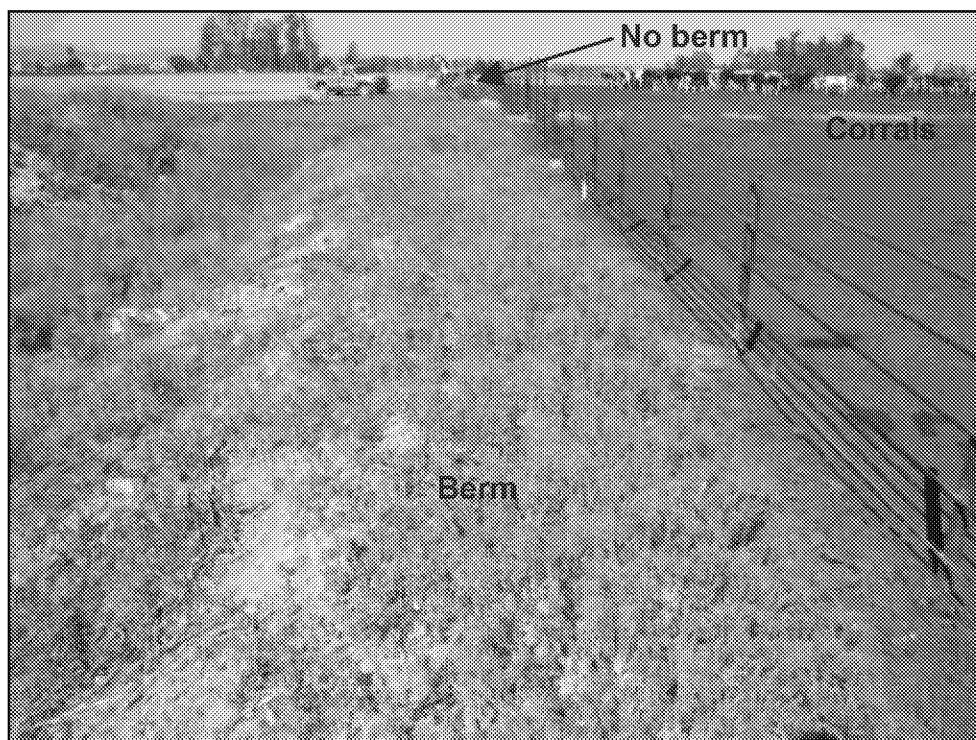
Photograph 12. View facing west of an earthen berm along the southern perimeter of the western corrals. Note the berm was not contiguous along the southern perimeter of the corrals.

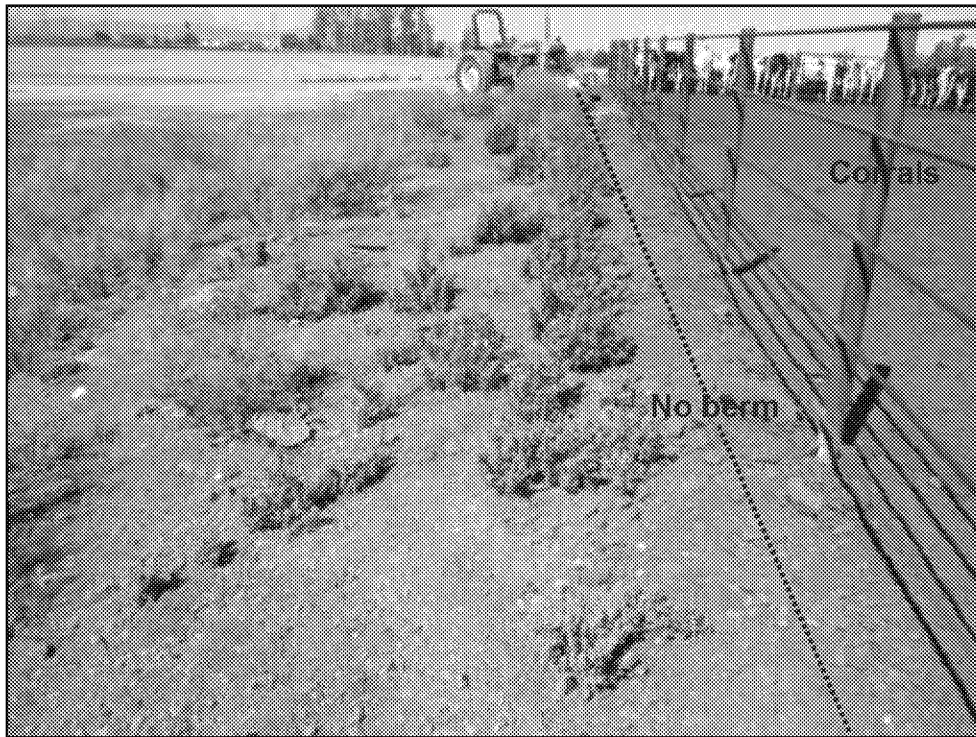
Photograph 13. View facing west along the southern perimeter of the western corrals. Note the earthen berm was not contiguous along the south side of the western corrals, shown in Photograph 12.

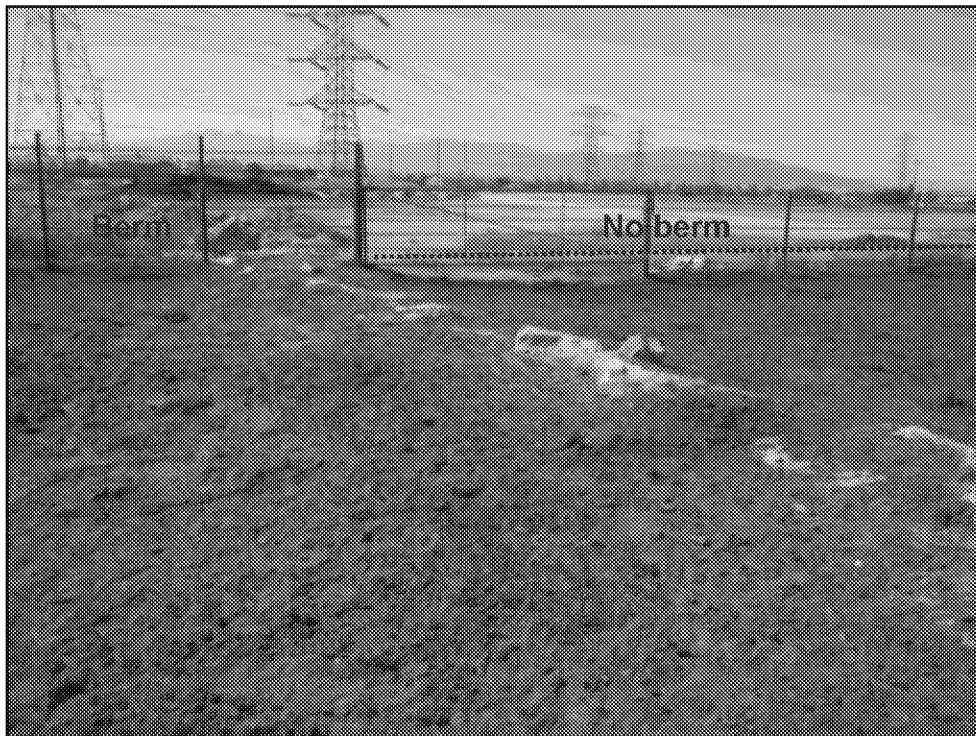
Photograph 14. View facing south of the southern perimeter of the western corrals. Note the earthen berm was not contiguous along the south side of the western corrals, as shown in Photographs 12 and 13.

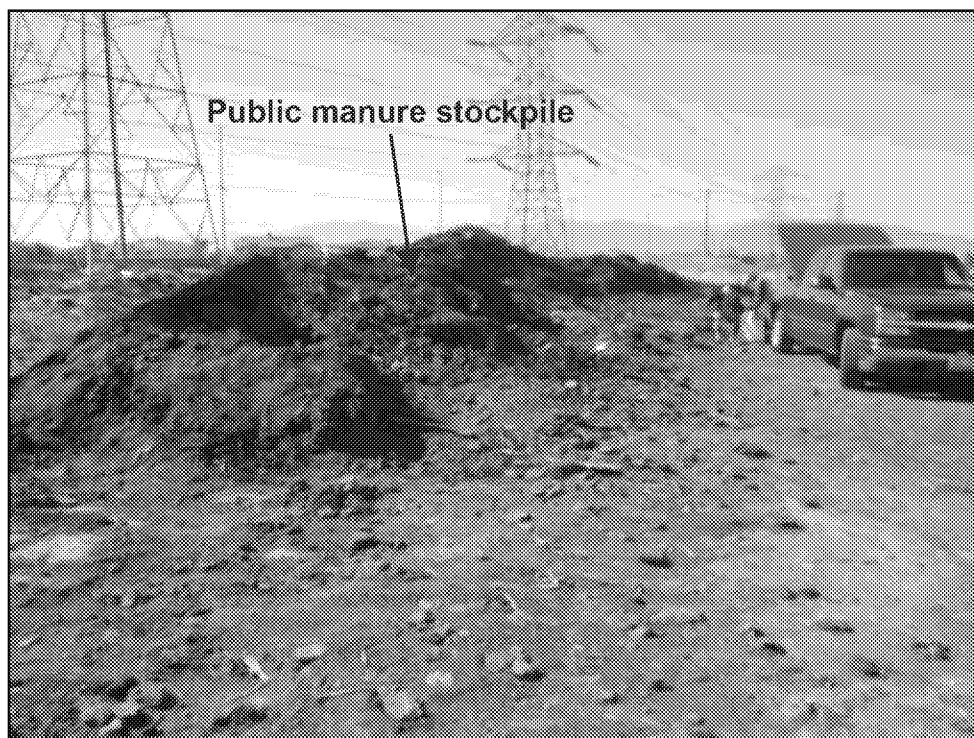
Photograph 15. View facing south of the public manure stockpile located in the southern portion of the Facility, west of the Facility containment structures.

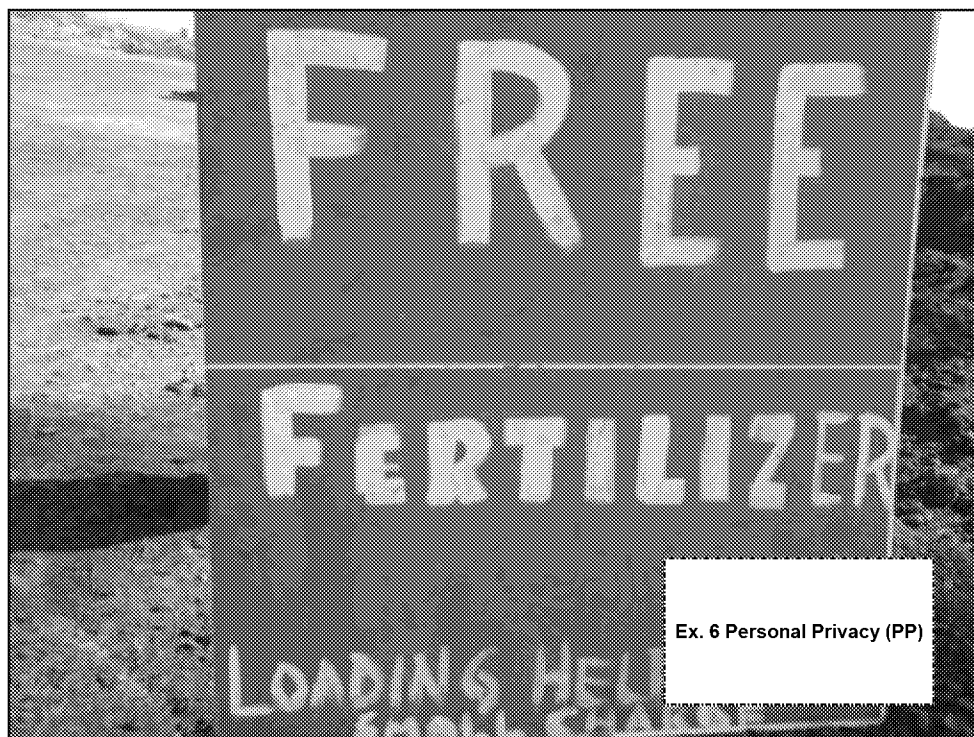
Photograph 16. Close-up view of the sign located at the public manure stockpile shown in Photographs 10 and 15.
